AKIN'S PRECISION HOME INSPECTION

InterNachi CPI.

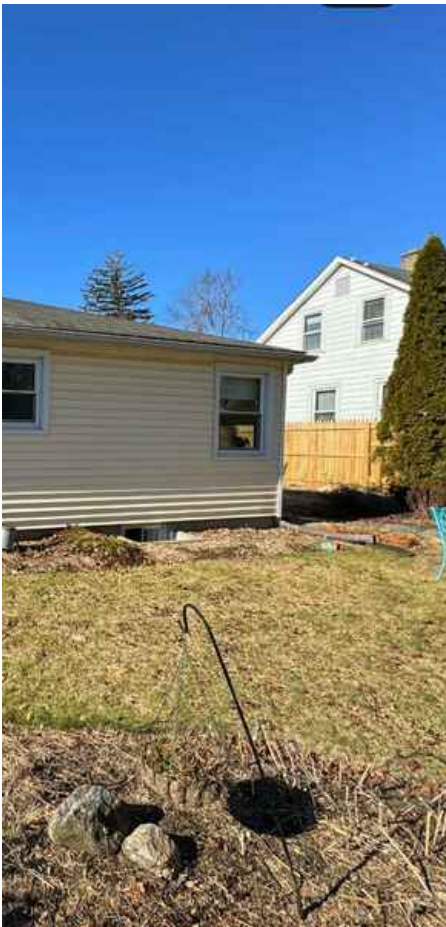
back of house

The general site grading of the property was well pitched from the home, with the exception of the rear of the house, where there are built-up flowerbeds and causing some areas to be pitched towards the house. This should be corrected so that no area of soil is pitched towards the foundation of the house.

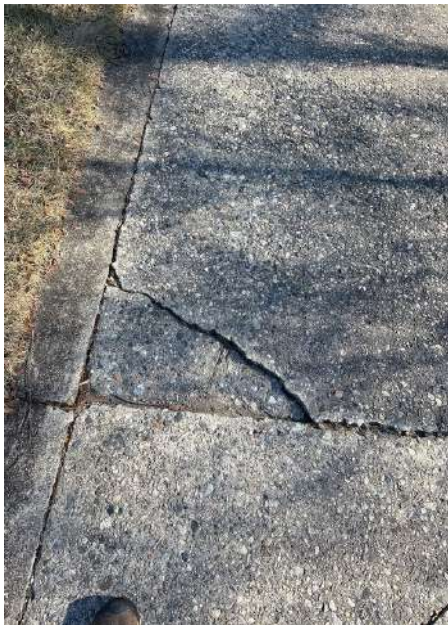
Driveway and Walkway Condition: Driveway

Left side of house to garage

Driveway is poured cement in relatively good condition, except for one area where it is cracked and damaged. Recommend contacting licensed Masonry or landscape contractor to assess and repair

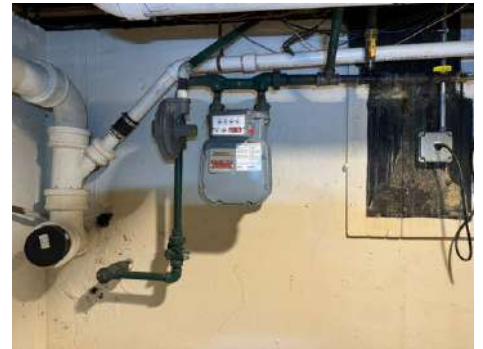
Main Gas Valve Condition: In basement

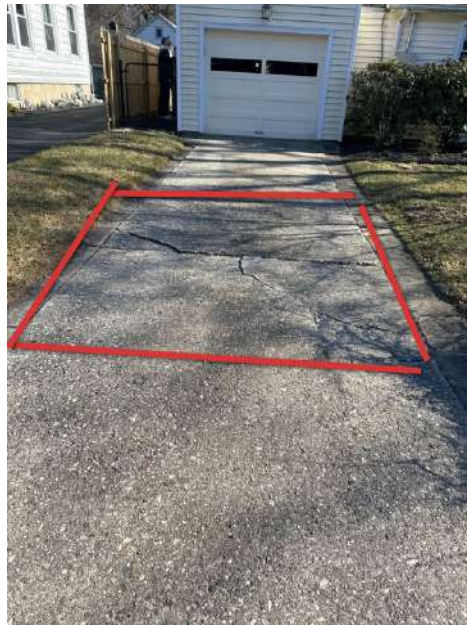
Driveway and Walkway Condition: Driveway connection point to Garage

There is a crack in the port cement from the driveway where connected to the garage. Recommend masonry contractor to seal crack to avoid water intrusion.

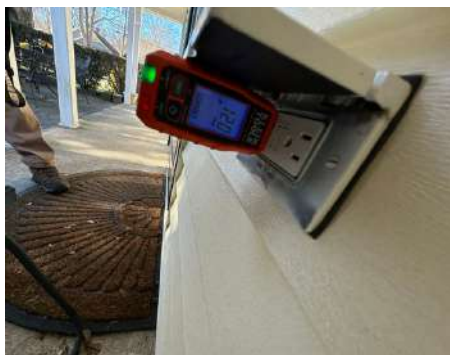
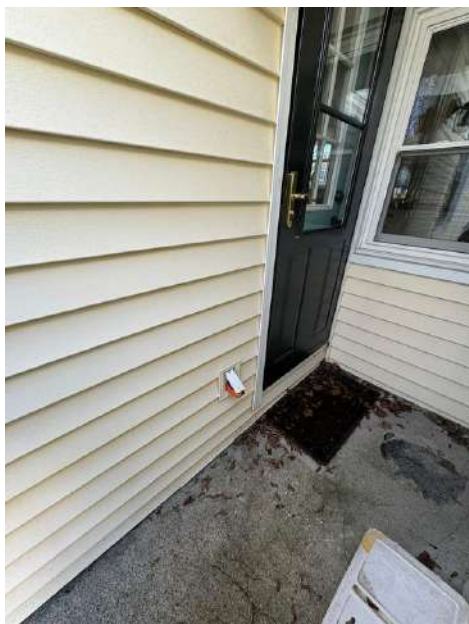
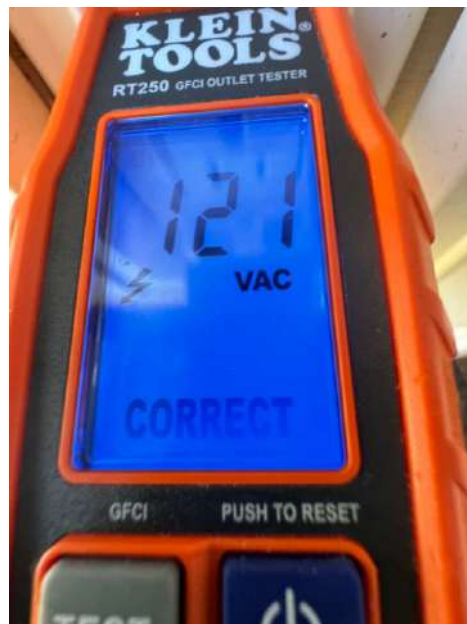
GFCI: All GFCI that were tested, were functioning at the time of inspection

To the right of the front entrance door and to the right of the kitchen exit door

The GFCI outlets that were tested on the exterior of the house were functioning as they should at the time of inspection.

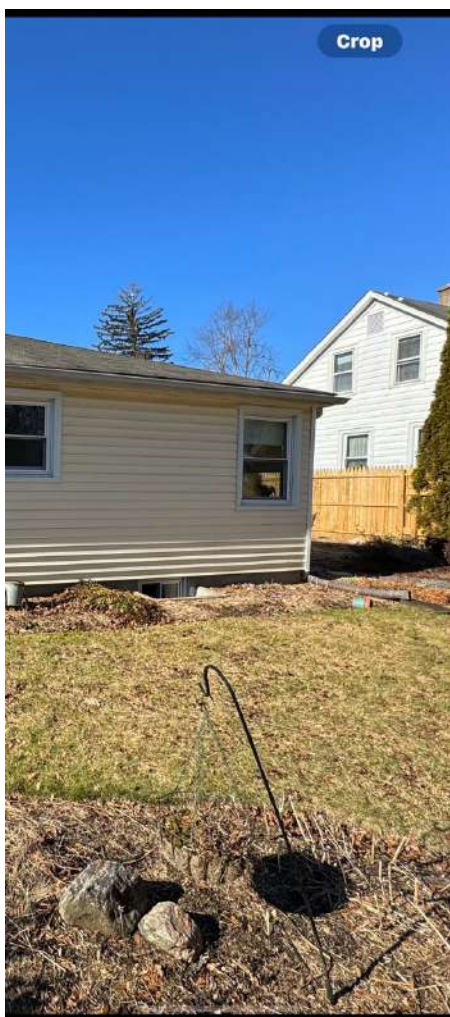
Grading: Lot grading and drainage have a significant impact on the building

Simply because of the direct and indirect damage that moisture can have on the foundation. It is very important, therefore, that surface runoff water be adequately diverted away from the home. Lot grading should slope away and fall a minimum of one (1) inch every foot for a distance of six (6) feet around the perimeter of the building.

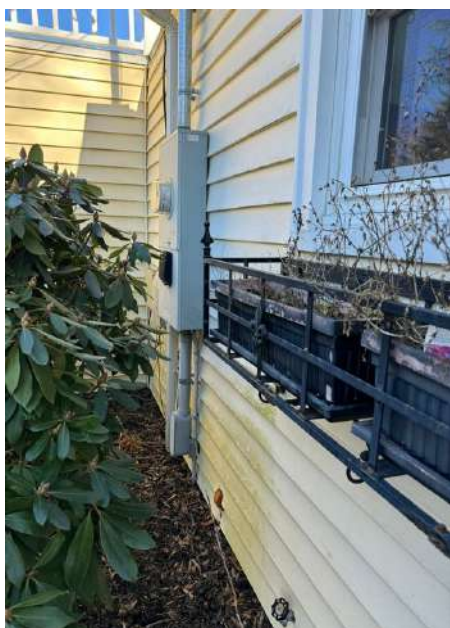
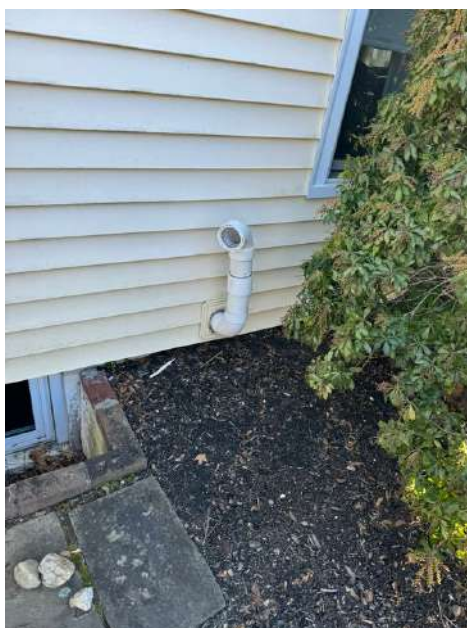
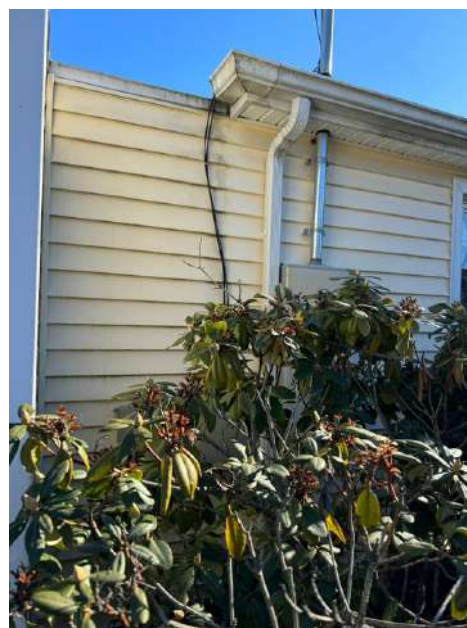
Vegetation Observations: Vegetation overgrowth

Rhododendron in front of house should be kept cut back to keep a clear area between the bush and the house. Vegetation that is close to the home can cause moisture to be trapped against the foundation and cause future damage.

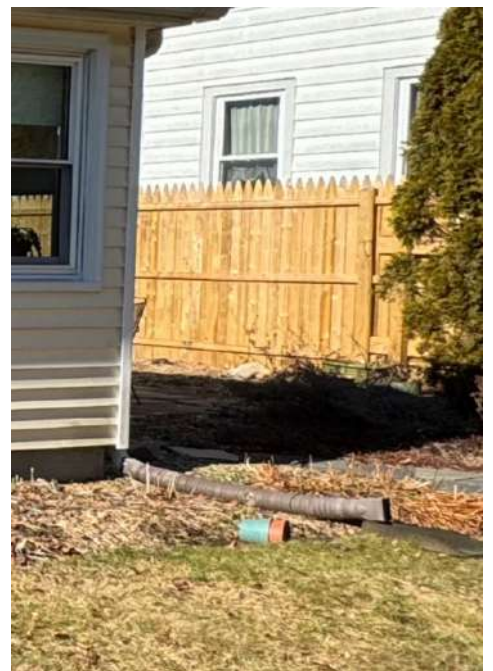
IMPROPER SLOPE TOWARDS FOUNDATION

At the back of the house, there are some raised flowerbeds which are directing water towards the foundation. also, the downspout left rear of house has an extension to a drain plate, but the drain plate is sitting too high on the ground and causing water to run back to the foundation.

Contact a qualified landscaping contractor

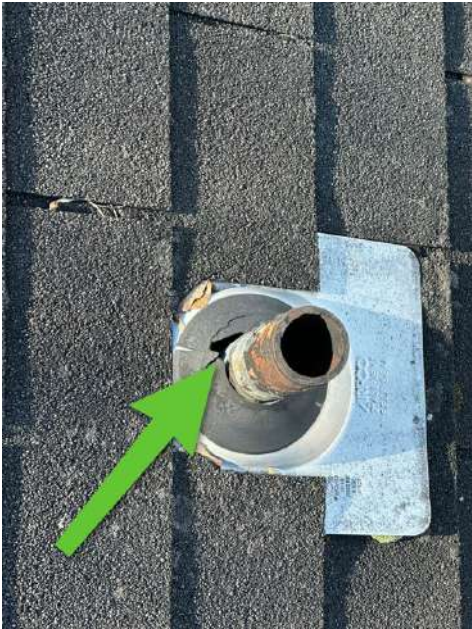
WASTE VENT PIPE, ROOF BOOT

Safety Hazard/ Major Defect

The boot for the waist vent pipe on the roof is in bad condition and must be replaced. Also, the waste vent pipe is too short. It should be extended to a 6 inches above the roofline. Recommend licensed roofing contractor.

Contact a qualified roofing professional.

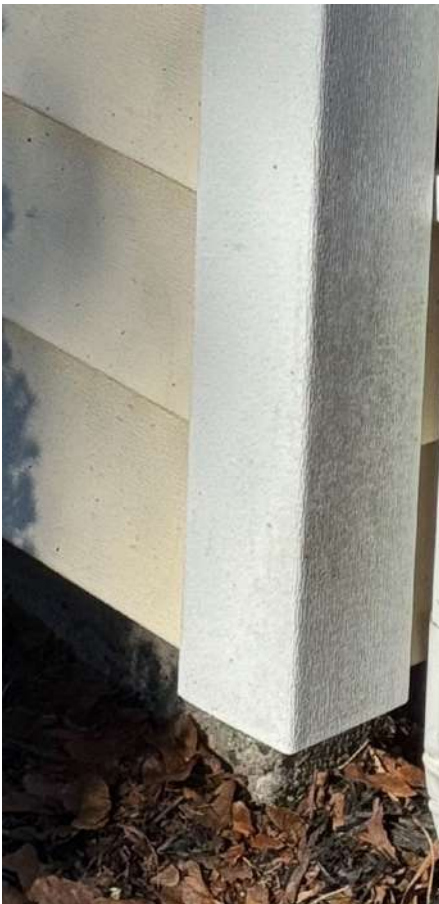
Siding Condition: No major system or safety concerns noted

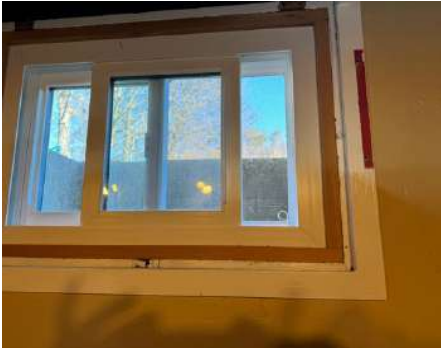
Window Condition: Components
appeared in satisfactory
condition at time of inspection

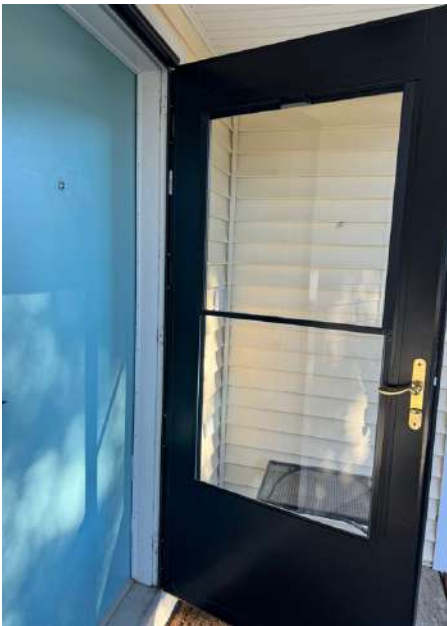
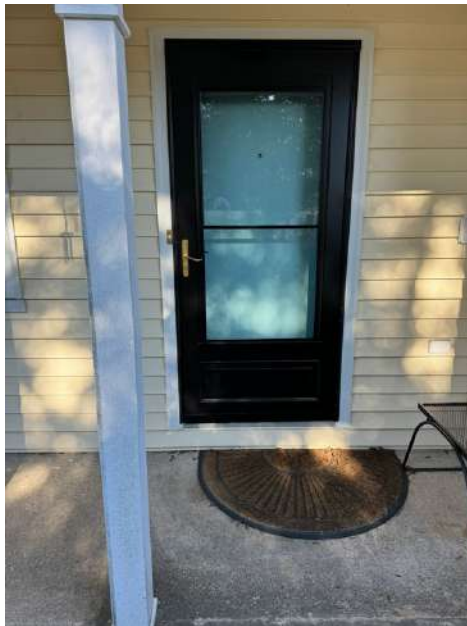
front entrance

Doors: Exterior Doors

Front entrance door closes properly, but the weather seal is worn. Recommend replacing weather seal.

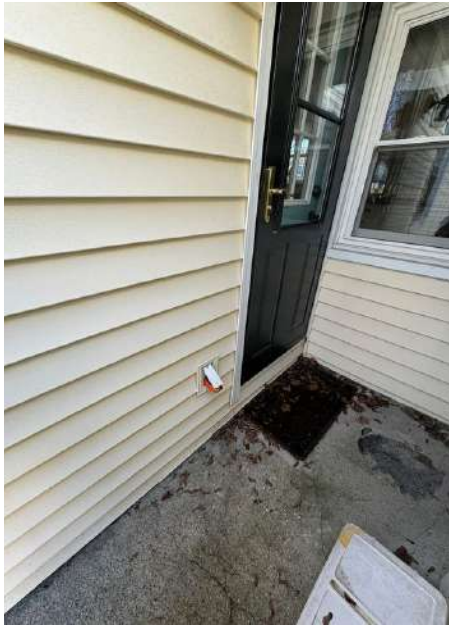
Back of house off kitchen

Doors: Rear entry door

Rear entry door is well sealed. Also, storm door has the required door closure attached.

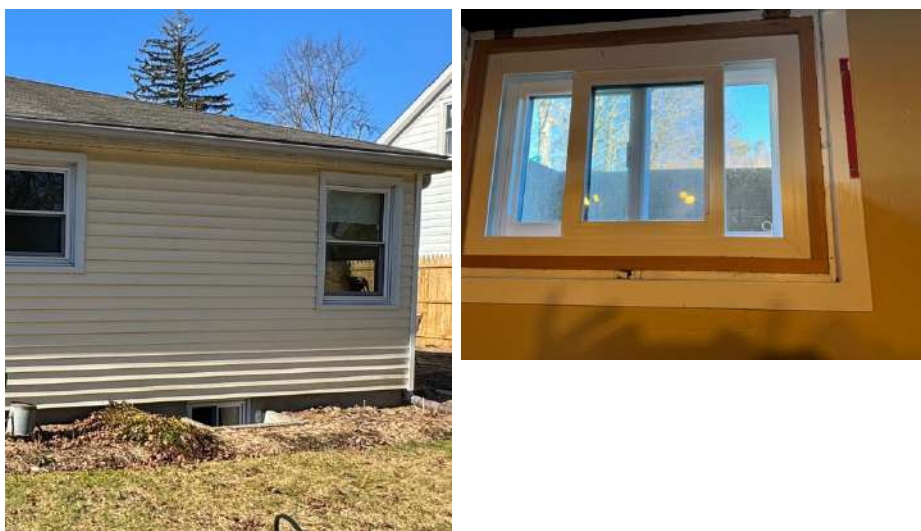
Window Condition: Recently installed energy, efficient, double pane, gas filled windows

All windows that were inspected operated and functioned as they should

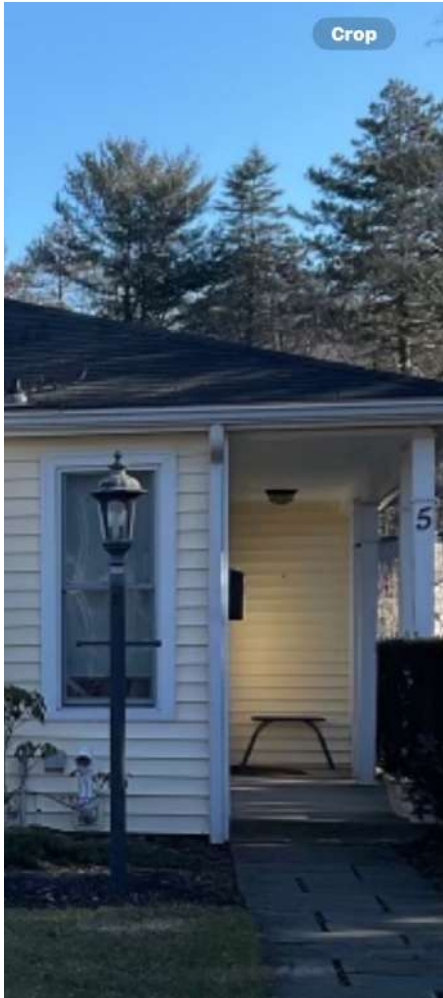
House, roof in porch roof one in the same

Roofing is the same as main structure., House, roof in porch roof one in the same

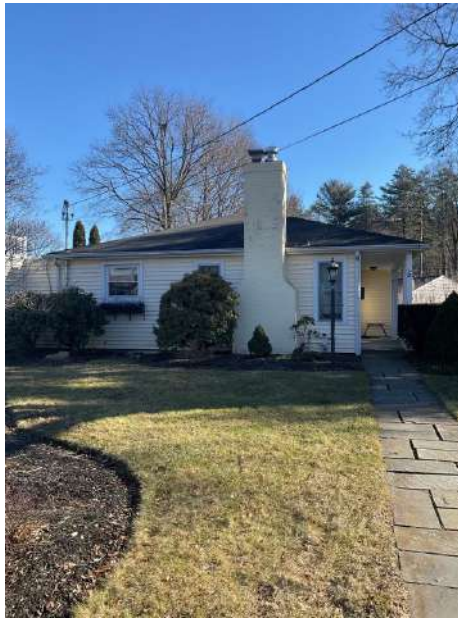
Material

Asphalt shingles noted.

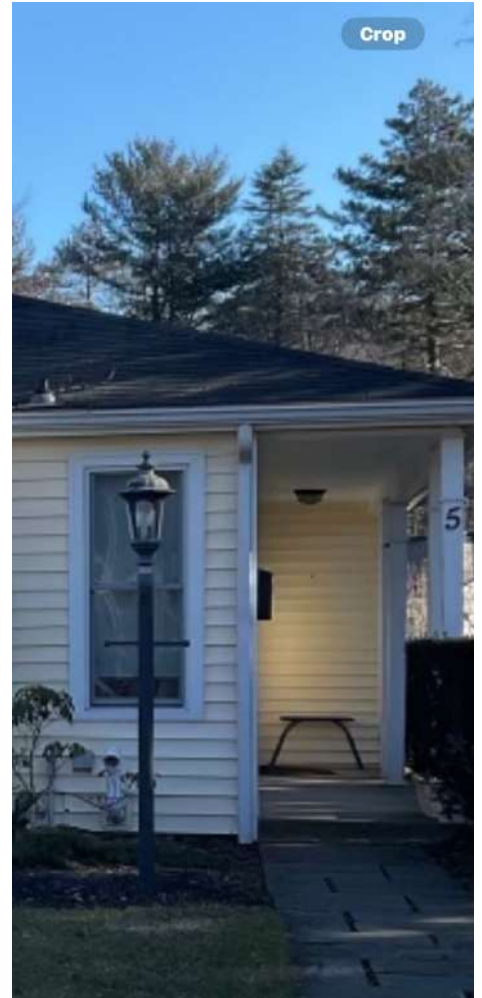
Patio and Porch Roof

House roof extended to porch roof

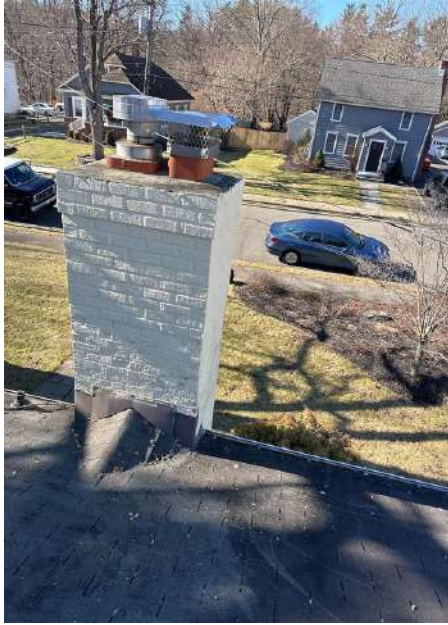
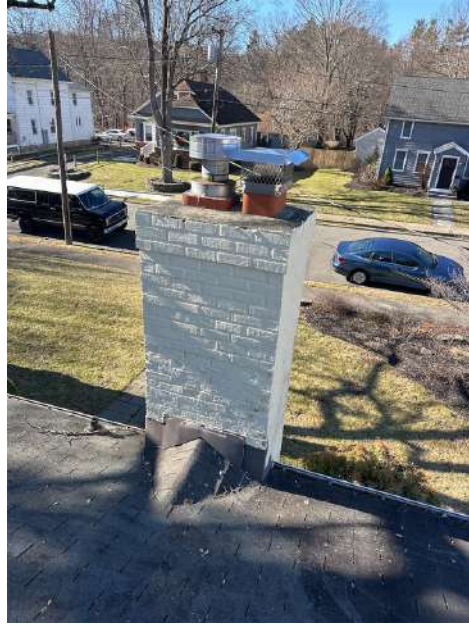
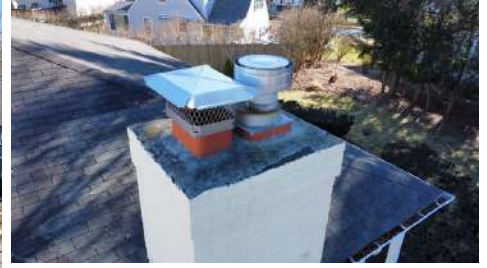
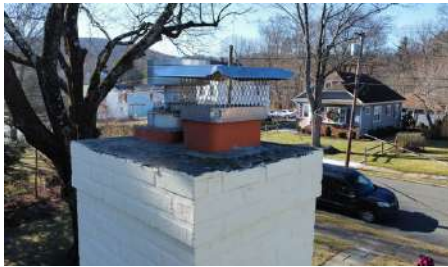
Front of house, Street side

Chimney: Brick chimney clay lined with new metal chimney cap

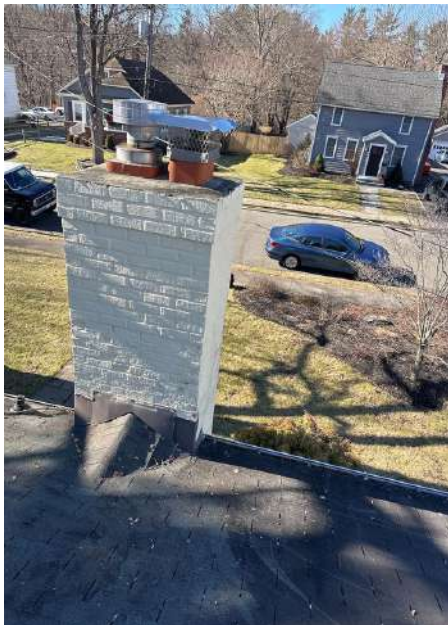
Flashing: Typical maintenance necessary

Now and on an annual or semi-annual basis. This generally consists of resealing gaps at through-the-roof projections and at the parapet walls as necessary.

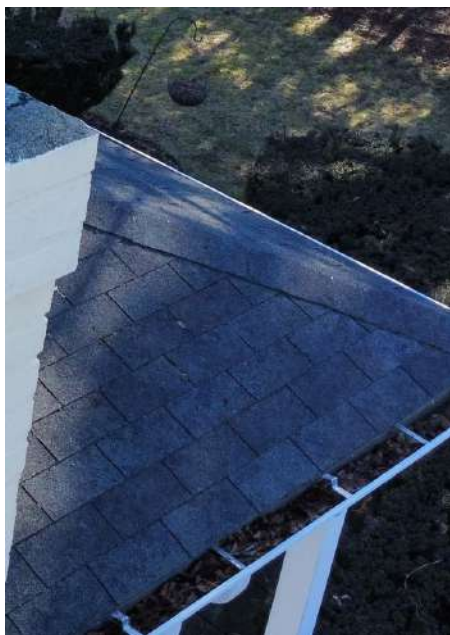
Gutter: Maintenance Tip

Keep gutters cleared of organic debris to prevent downspouts from being clogged causing overflow at gutters, ensure that all downspouts have extensions/splash blocks to carry water away from the foundation.

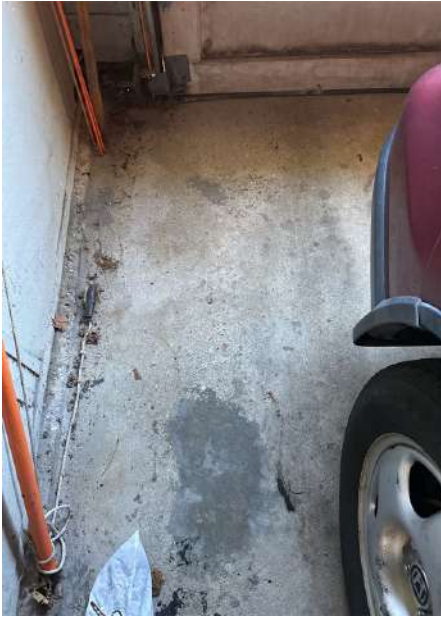
Floors

Bare concrete floors noted.

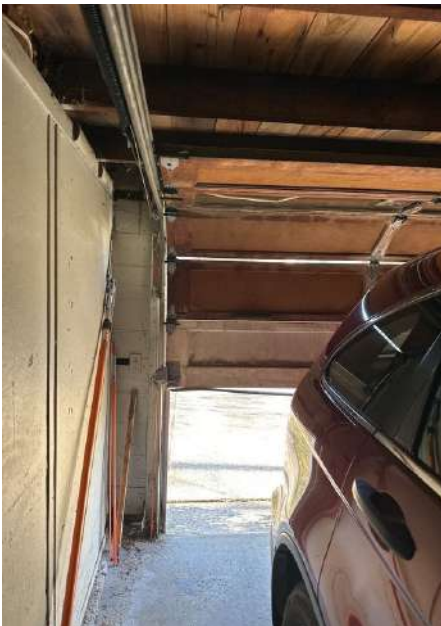
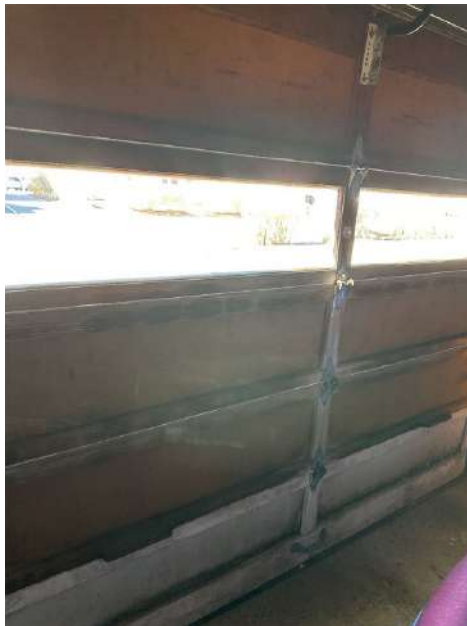
Door Type

Sectional door noted.

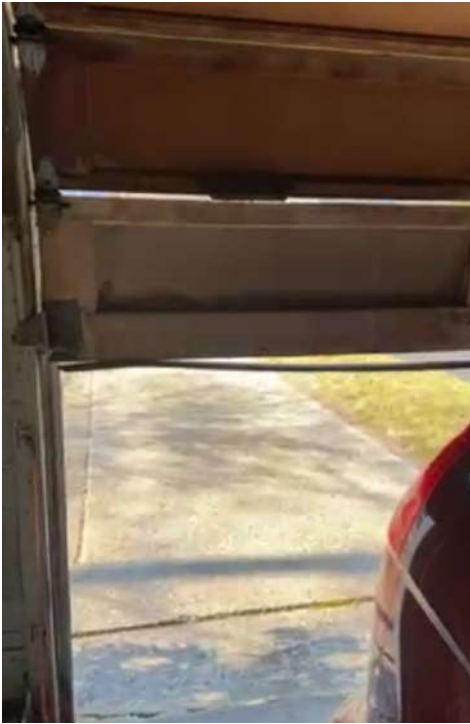
GARAGE DOOR WEATHERSTRIPPING

Garage door, weatherstripping, loose and hanging. Recommend replacing weatherstripping, recommend consulting with a licensed Garage door contractor

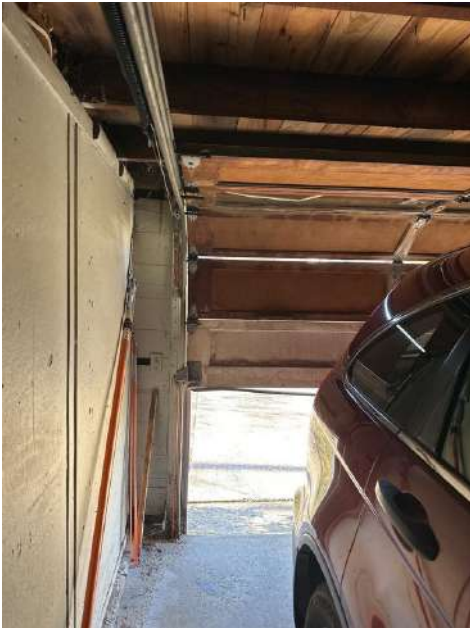
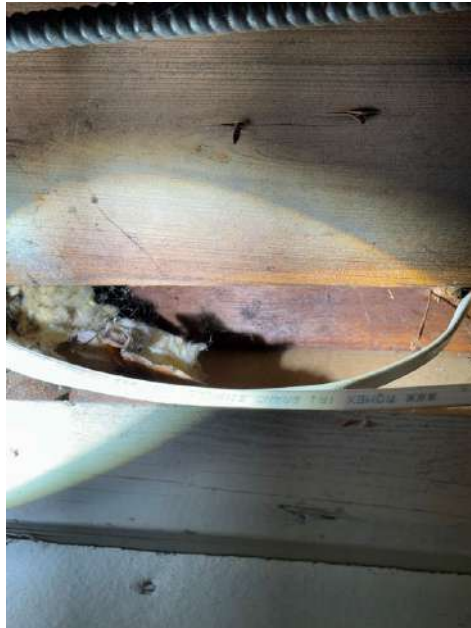
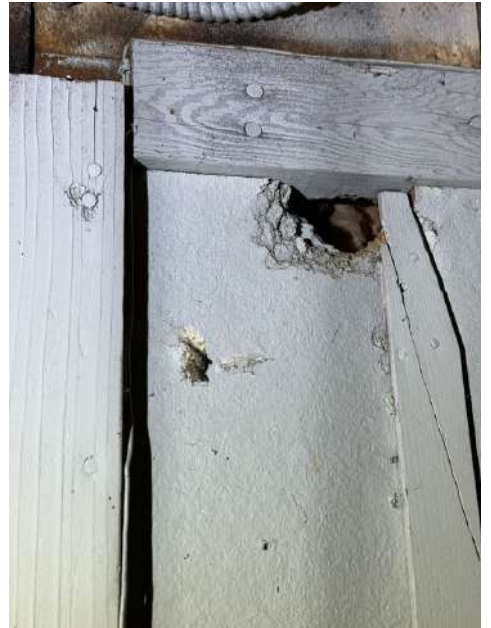
6.9.1 Walls

FIRE WALL BETWEEN GARAGE & HOUSE NOT CONTINUOUS

Contact a qualified professional.

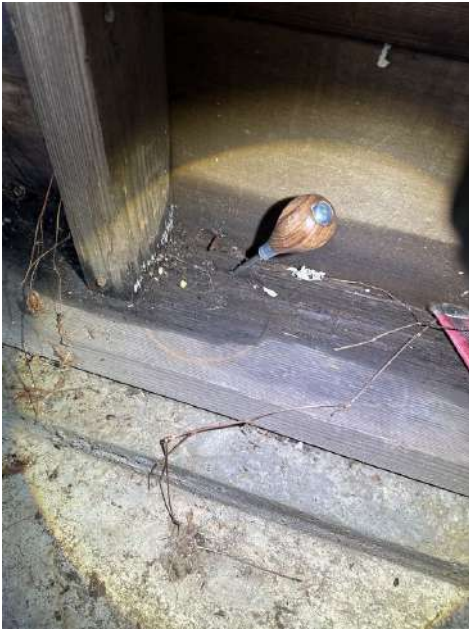
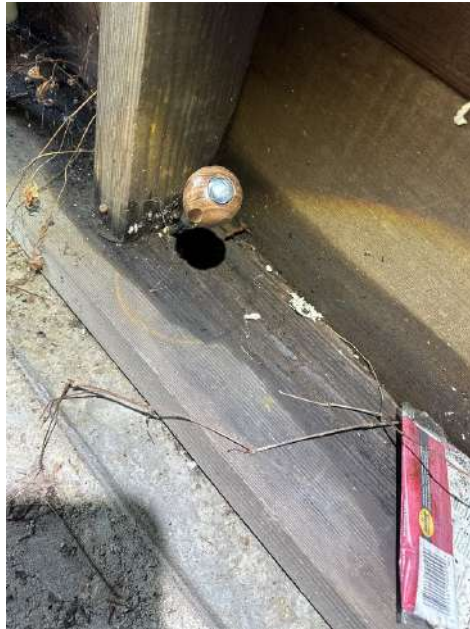
6.9.2 Walls

EXTERIOR GARAGE WALL

Observed water moisture on sill plate base of wall

Contact a qualified professional.

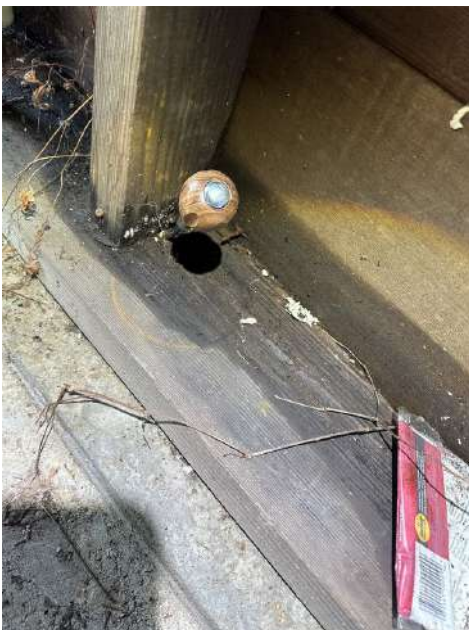
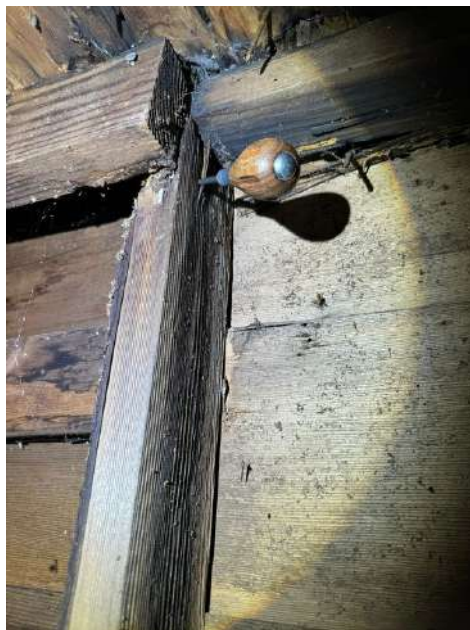
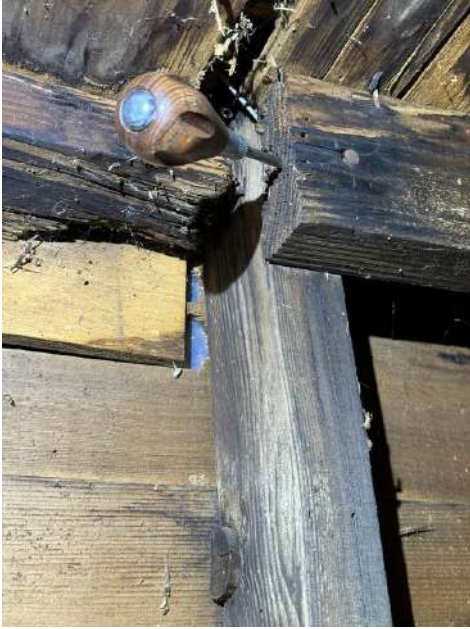
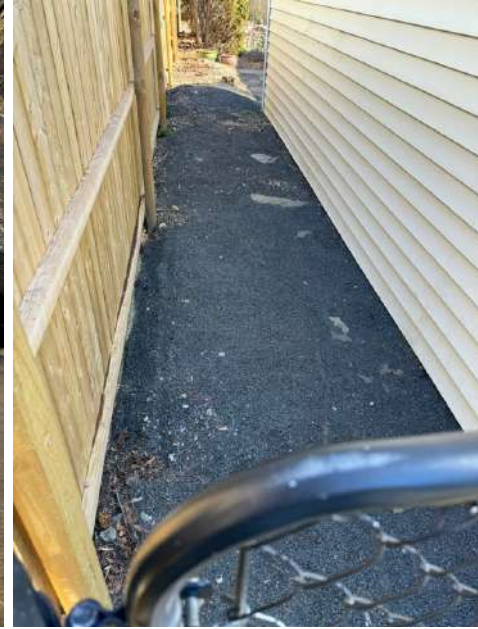
6.11.1 Sill plates, and wall studs

SILL PLATES IN WALL STUDS ARE CONTAINING A LARGE AMOUNT OF MOISTURE

Sill plates and wall studs are containing a large amount of moisture left side of the garage and back wall and some areas are rotting. It appears that the sill plate in the garage on the left side is wicking up, moisture from the gravel walkway to the left of the garage.

Gravel walkway pitched towards garage

Recommend a licensed landscaper, to evaluate and create proper drainage at the walkway.

Recommend a licensed home remodeling contractor to evaluate damage, sill plate, and wall studs.

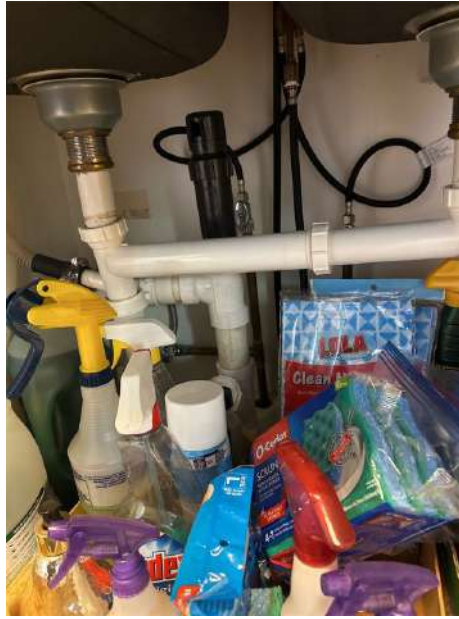
Plumbing: No leaks under the sink were observed when water is run at time of inspection

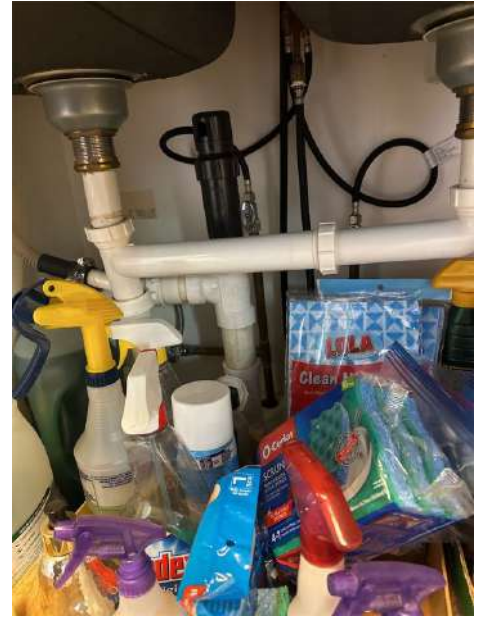
Sinks: No leaks under the sink

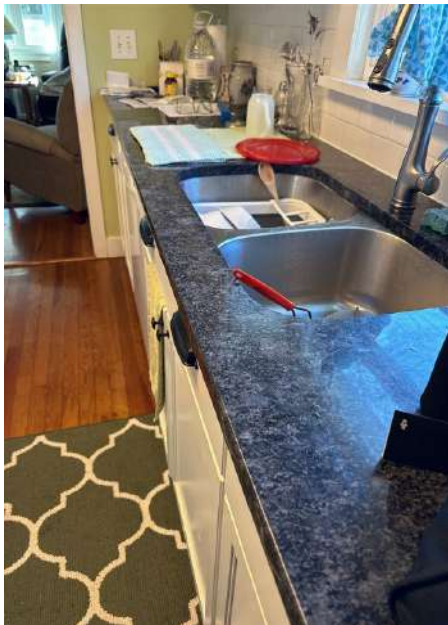
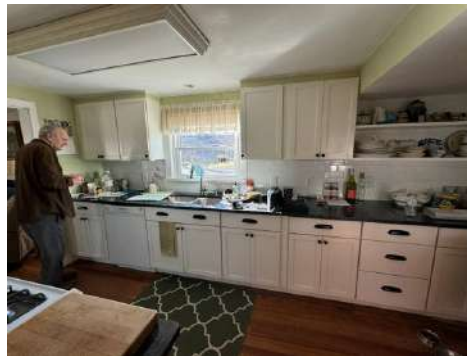
Counters: Solid Surface counter tops noted

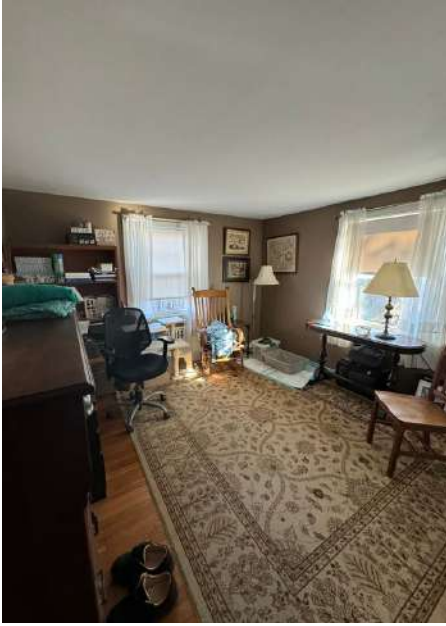
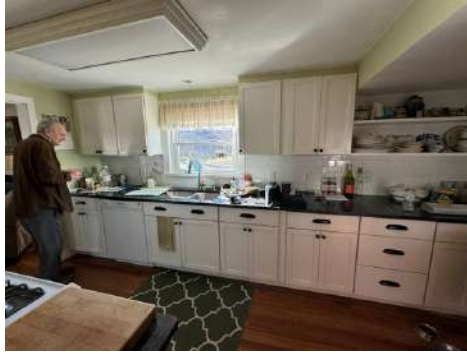
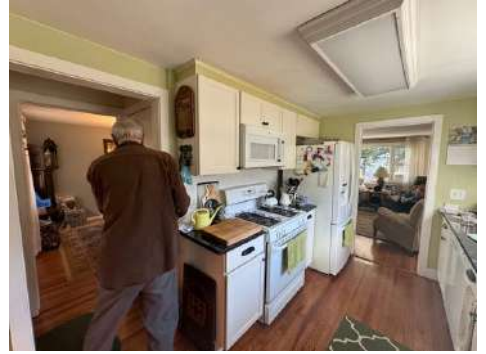
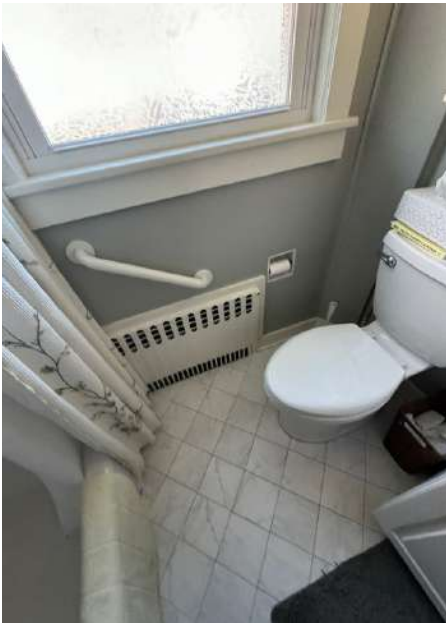
Floor Condition: Floors

All main floors are hard wood excluding the bathroom floor, which is tile

Hard wood flooring throughout with the exception of the tiled bathroom floor

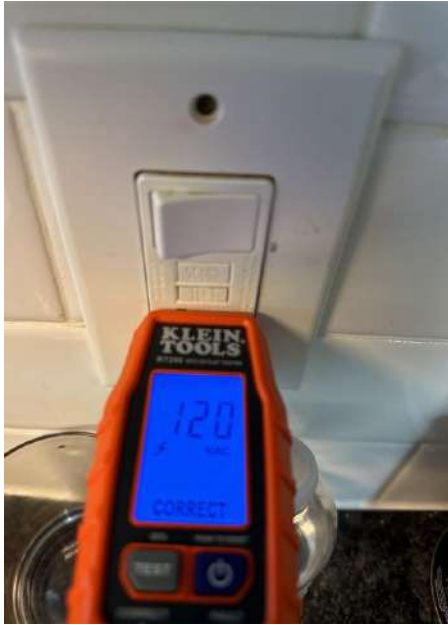
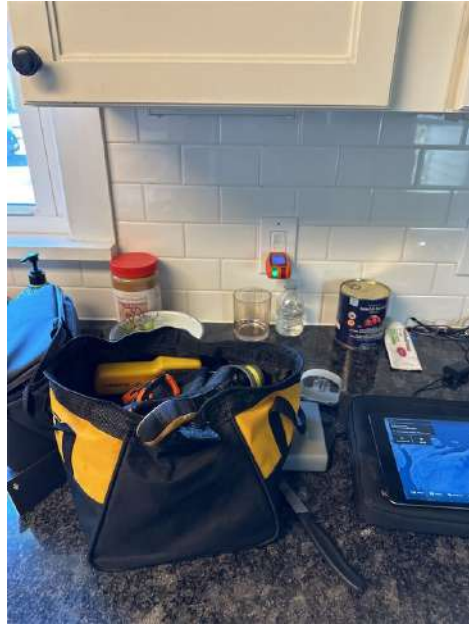
GFCI: GFCI in place and operational

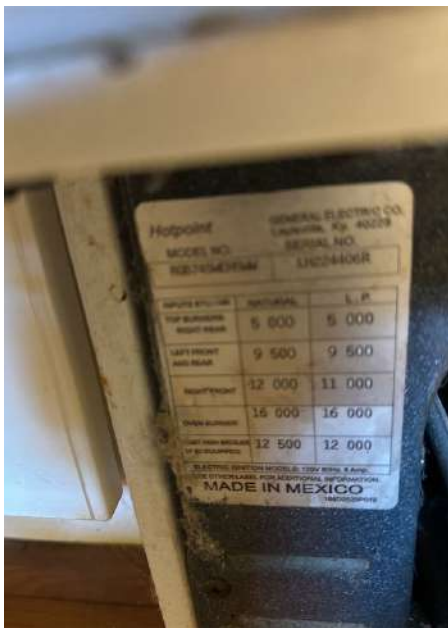
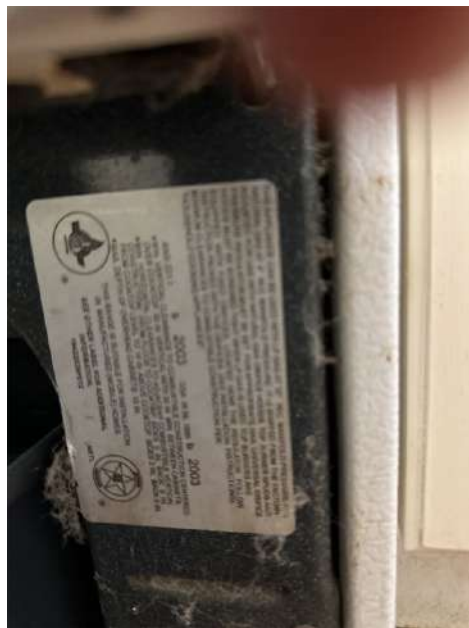
Oven & Range: Oven

Propane gas burners

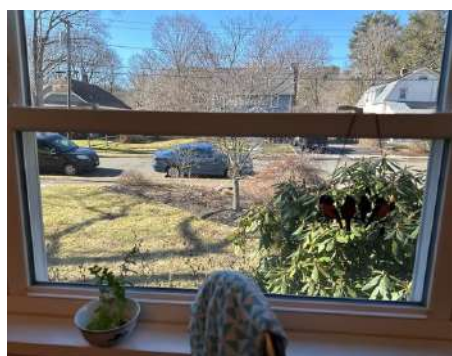
Window Condition: Windows tested, were functional and worked as they should at time of inspection

Windows are fairly new energy efficient windows that appear to function as they should at time of inspection

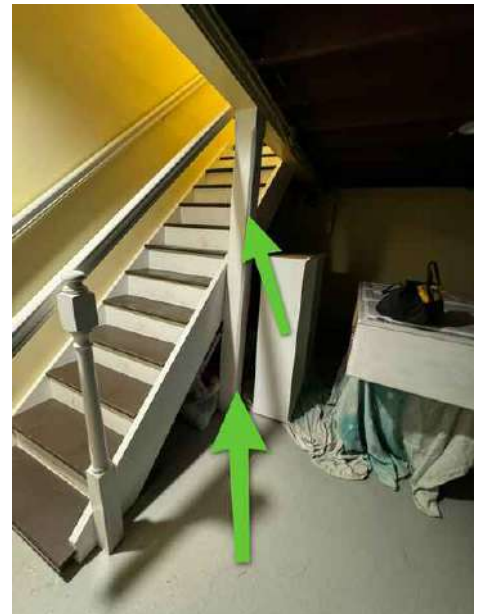
Columns: No deficiencies were observed at the visible portions of the structural components of the home
Basement

Support column in basement

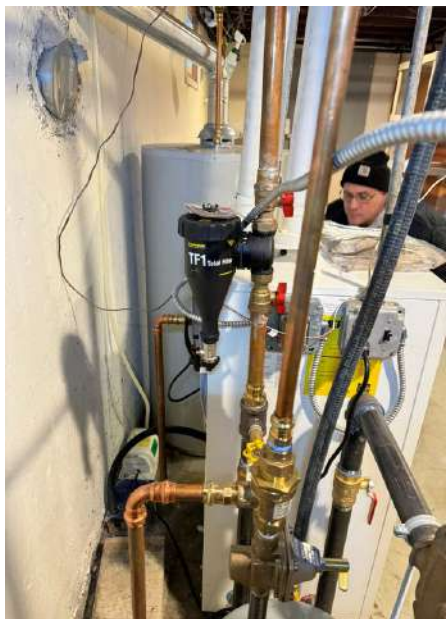
Plumbing Materials: Copper

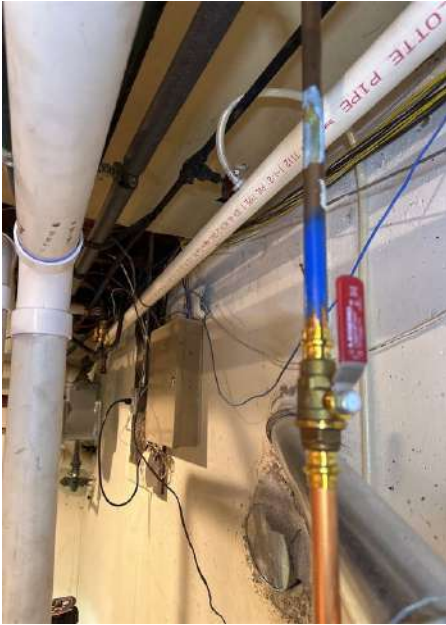
Plumbing Materials: Pex

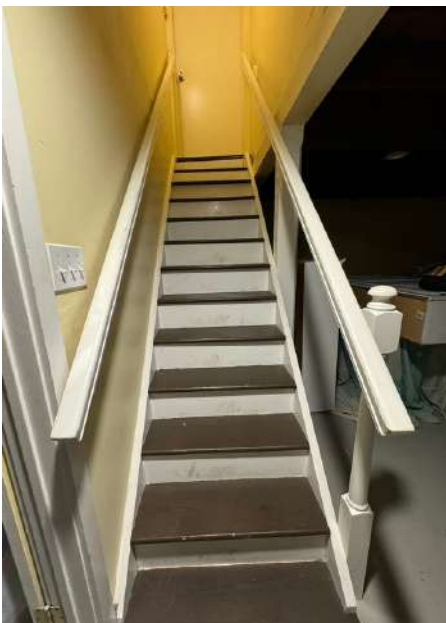
Railings: I did not observe any indications of railing defects during my inspection

The rails running down the stairwell to the basement are graspable and well secured

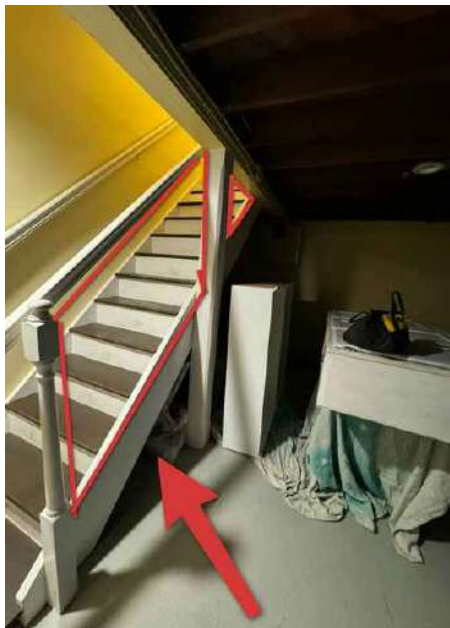
Kitchen area to basement stairwell

Stairs: Stairwell deficiency

Although there are graspable solid handrails on the basement stairwell there is a deficiency in the amount of open space to the floor of the basement from the stairs. This is particularly dangerous for small children.

Large gaps not safe for small children

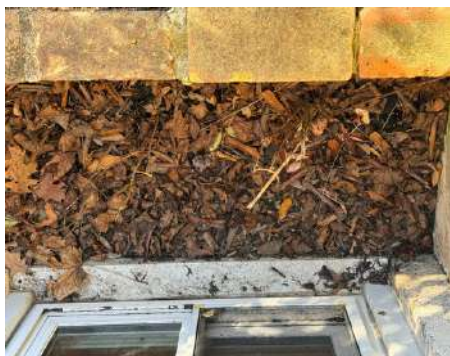
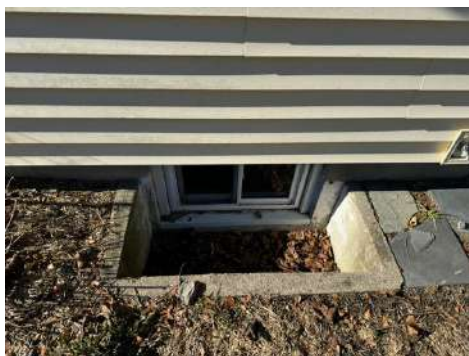
Windows: Operated windows appeared functional

Basement windows are below grade and have exterior window wells. The windows function as they should at the time of inspection. However, maintenance is needed outside in the exterior window wells. There are leaves and debris in the window well. This should be removed and kept clear of objects. Leaves and debris can retain water and therefore there could be water intrusion. Recommend handyman to clear window wells of leaves and debris and have exterior window covers installed. These areas should have regular maintenance.

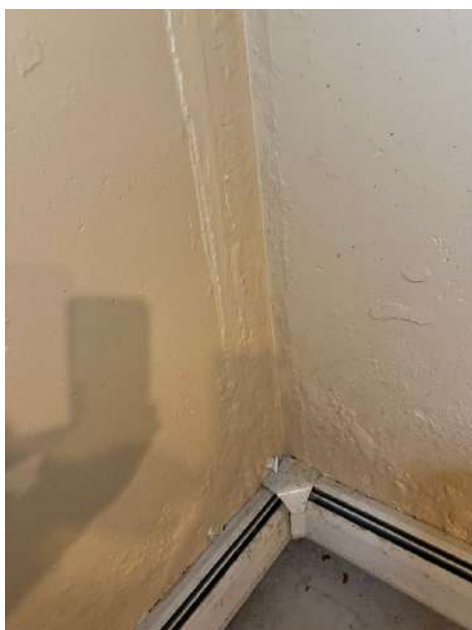
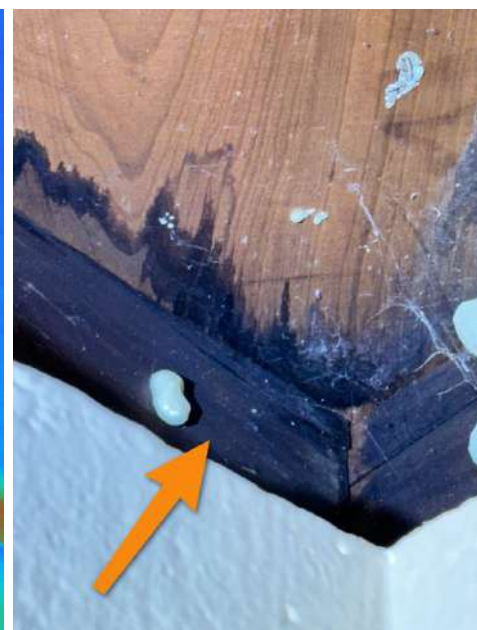
moisture intrusion stains

MOISTURE INTRUSION OBSERVED IN BASEMENT

Basement room left of stairs left corner of room is showing spalling that has been painted over and water staining at top edge of wall. Did not observe any water penetration at time of inspection. Recommend foundation contractor to evaluate moisture intrusion, and possible sealing of exterior foundation.

Contact a foundation contractor.

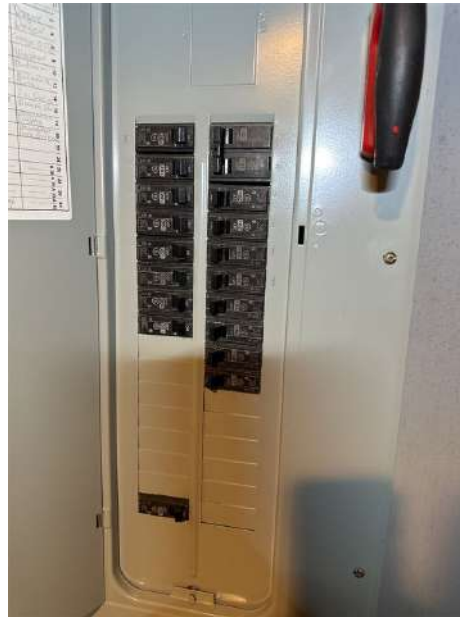
Breakers in off position: 0

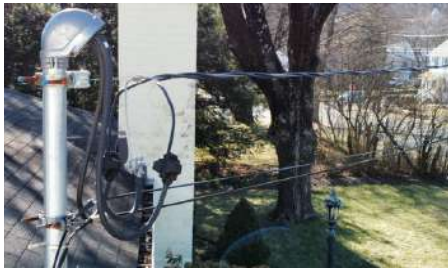
Left side front of house

Cable Feeds: There is an overhead service drop noted

This is a relatively new electric service. The service mast, drip loop and service conductors are all in proper condition. However, the service mast support cable is no longer connected. Recommend a licensed electrician to correct the situation.

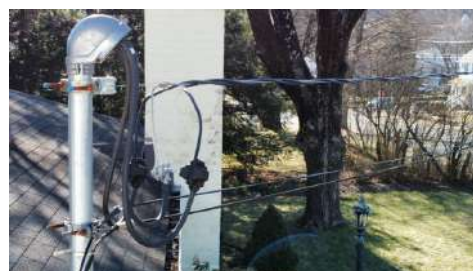
Anchoring cable for electrical service mast disconnected.

SUPPORT CABLE FOR ELECTRICAL MAST NO LONGER CONNECTED

Recommend licensed electrician to reconnect, anchoring cable to service mast

Recommend licensed electrician to assess and correct the situation

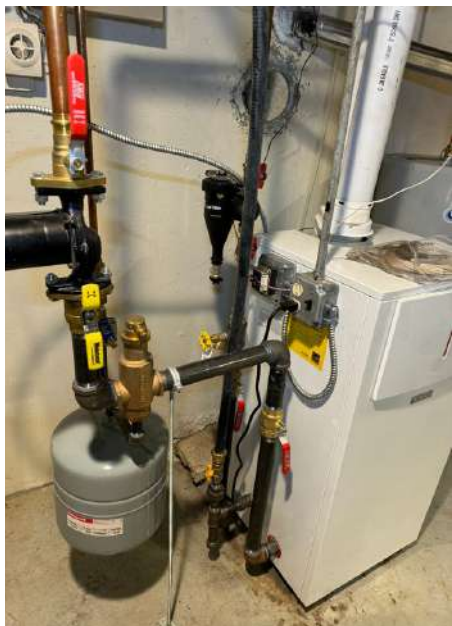
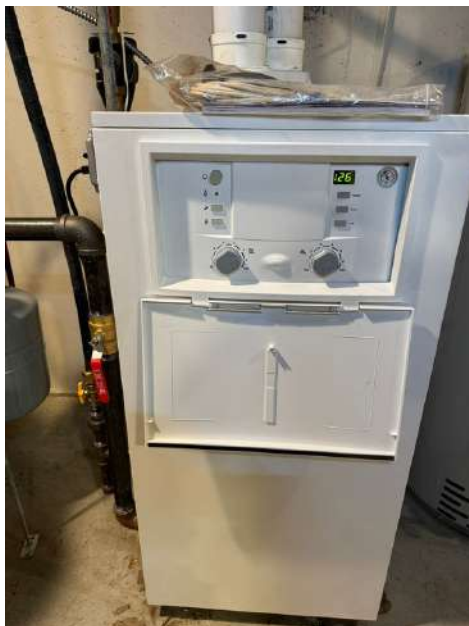
Basement right at bottom of stairs

Heater Condition: High efficiency, natural gas boiler

Unable to identify manufactured date. Boiler installed new roughly 4 years ago according to homeowner.

Natural gas water boiler functioned as it should at time of inspection. No defects noted at time of inspection.

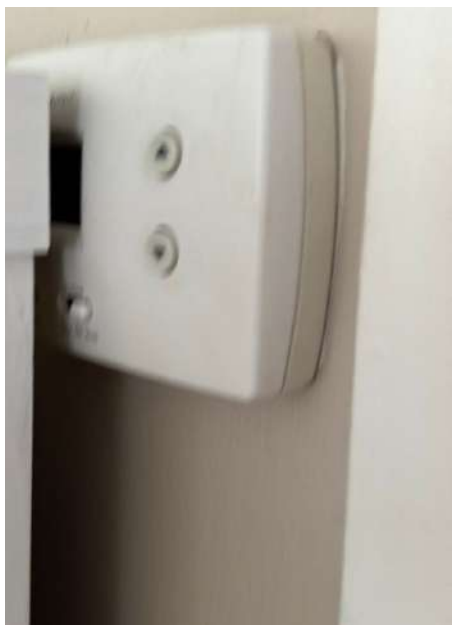
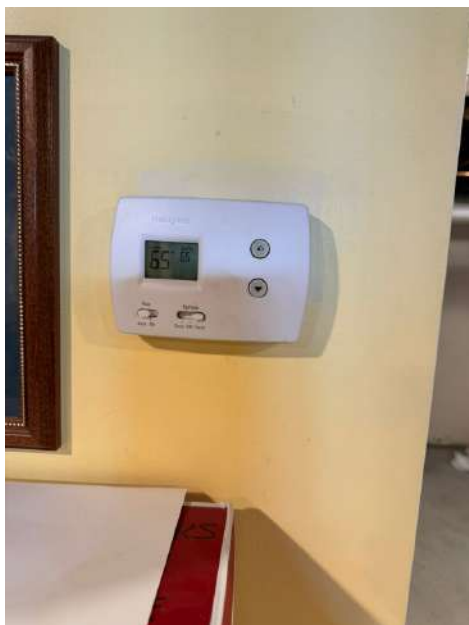
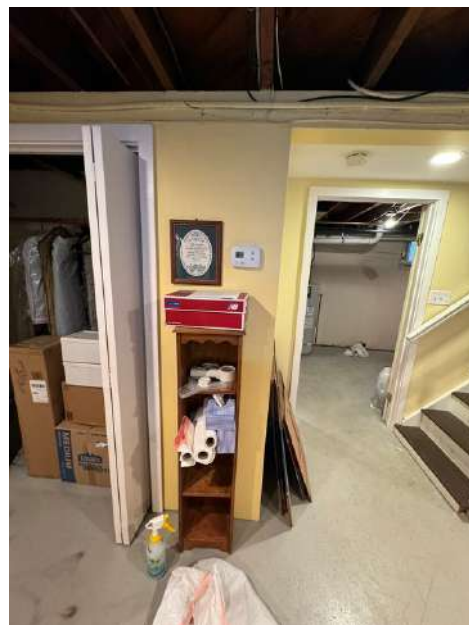
main floor left of dining room entrance and basement bottom upstairs

Thermostats: Location

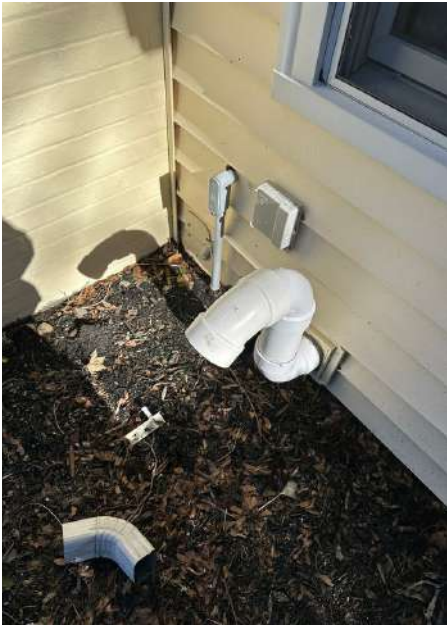
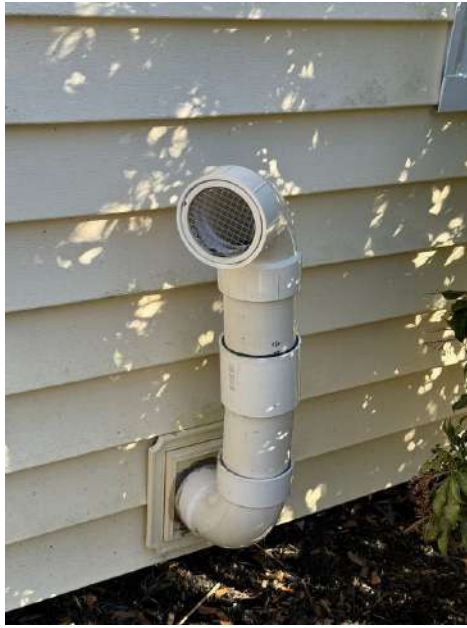
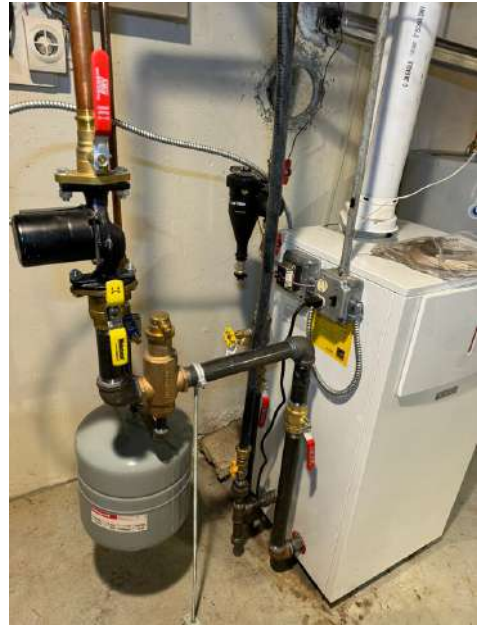
Basement, front of house and front of house exterior

Venting: **VENTING MATERIALS**

PVC venting pipes
