AKIN'S PRECISION HOME INSPECTION

InterNachi CPI.

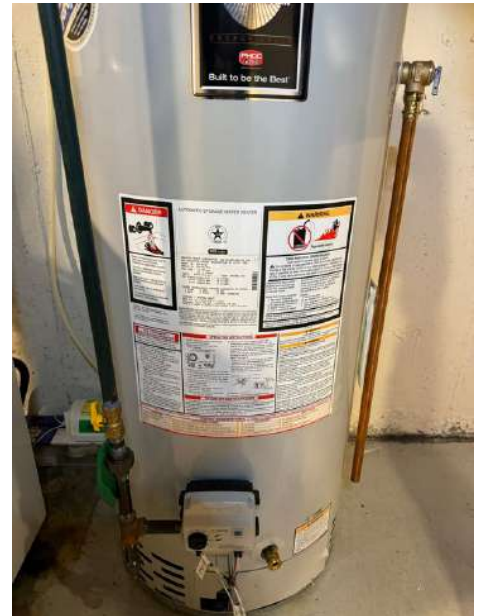
Basement right of stairs

Overflow Condition: Appears to be in satisfactory condition at the time of the inspection

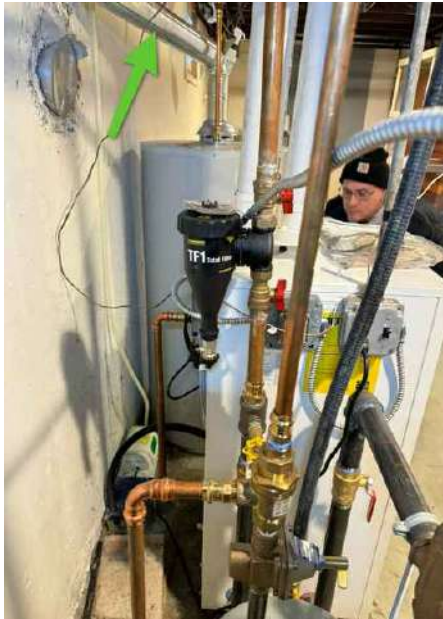
Basement

Venting: I did not observe any indications of defect to the water heater venting during my inspection

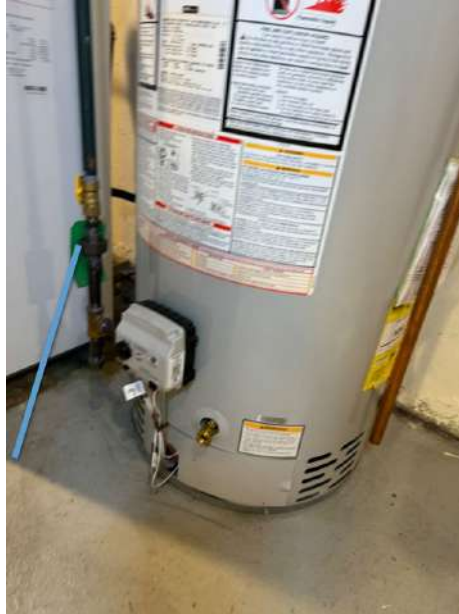
Left of water heater

Gas Valve: Appears functional

Gas shut off valve was clean and had no defects at time of inspection

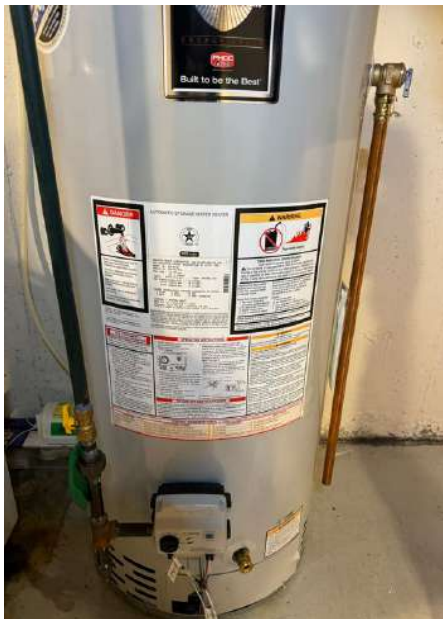
Basement right of stairs

Natural gas, hot hot water heater

This hot water heater was installed new within the past four years. it was functioning as it should, and I saw no signs of defects at the time of inspection

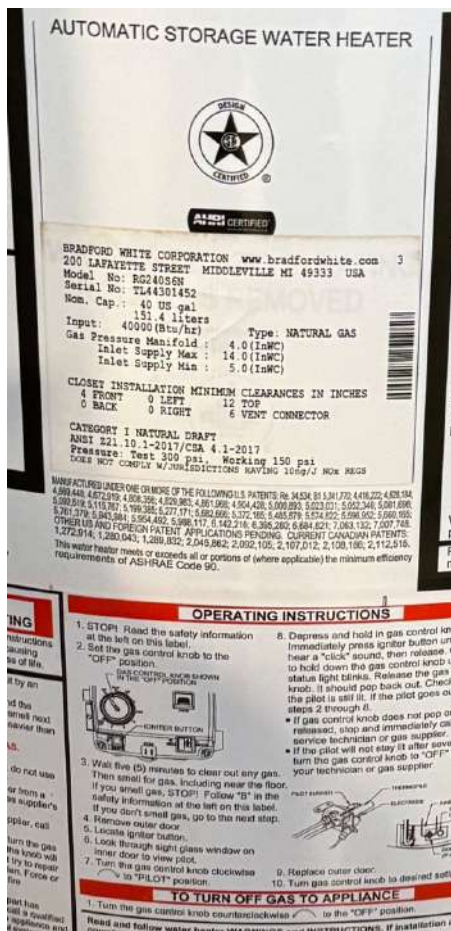
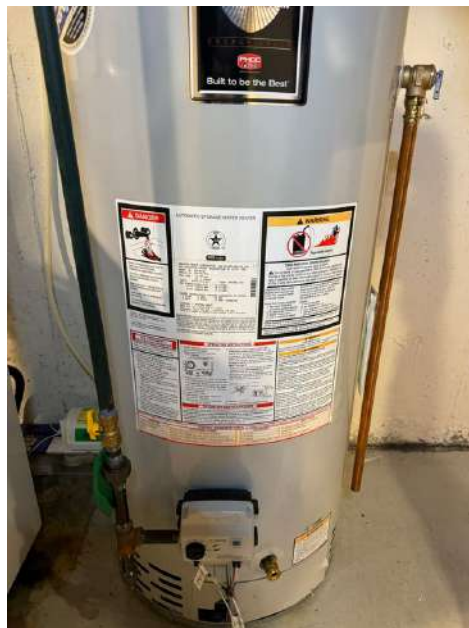
Boiler room basement, right of stairs

Combusion: Water heater, combustion chamber

Water heater functioned as it should and combustion chamber Was viewed as satisfactory at time of inspection

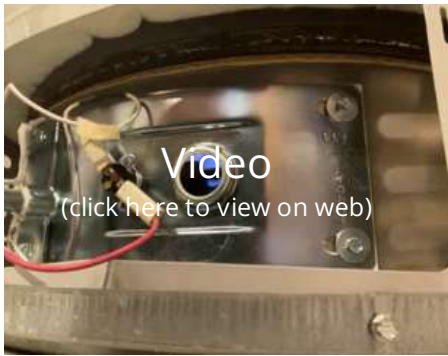
basment

TPRV: A Temperature Pressure Relief Valve (TPR Valve) present

This safety valve releases water (and thus relieves pressure) if either the temp or pressure in the tank gets too high. The TPR valve discharge tube must be made of copper, iron, or CPVC (NOT regular PVC). It must terminate within 6" above the floor--the end cannot be threaded or have a fitting.

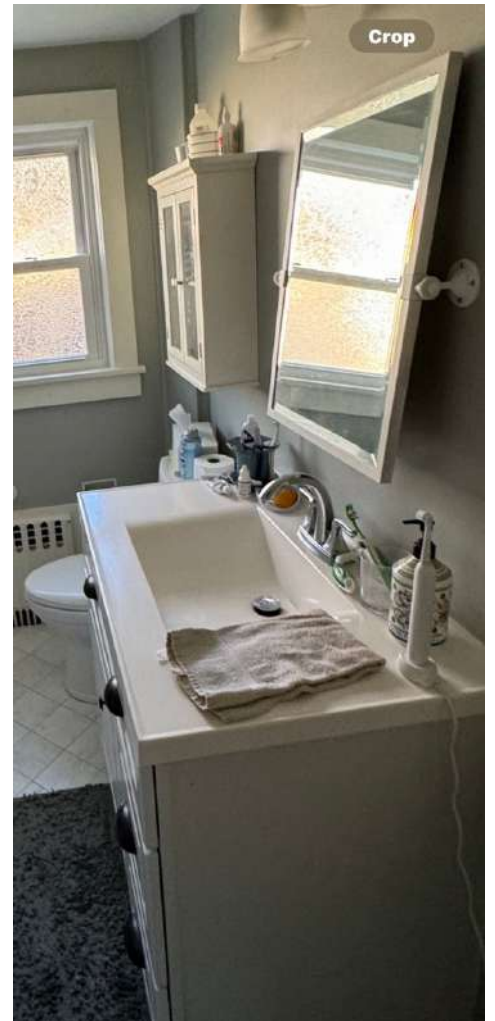
12.9.1 GFCI

Electrical outlets in this bathroom appeared to be in serviceable condition at the time of the inspection but had no Ground Fault Circuit Interrupter (GFCI) protection. Although this condition may have been commonly considered safe or acceptable at the time the home was originally constructed, as general knowledge of safe building practices has improved with the passage of time, building standards have changed to reflect current understanding. Consider having GFCI protection installed as a safety precaution for outlets within 6 feet of a plumbing fixture. This can be achieved by: 1. Replacing the current standard outlets with GFCI outlets 2. Replacing the outlet in this bathroom circuit which is nearest the main electrical service panel with a GFCI outlet. 3. Replacing the breaker currently protecting the electrical circuit which contains these bathroom outlets with a GFCI breaker.

Contact a qualified electrical contractor.

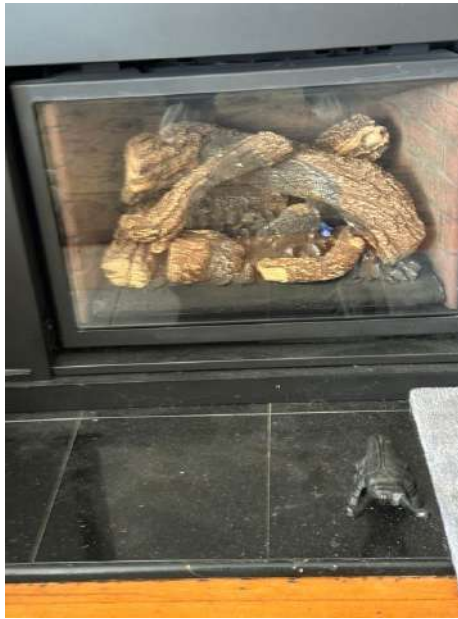
Fireplace Materials

Natural gas fireplace insert, Brick

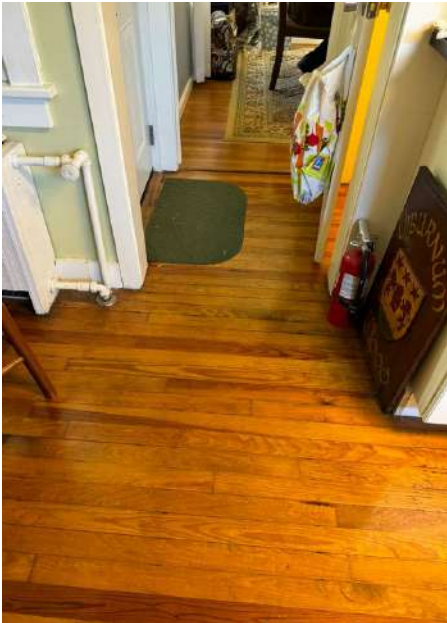
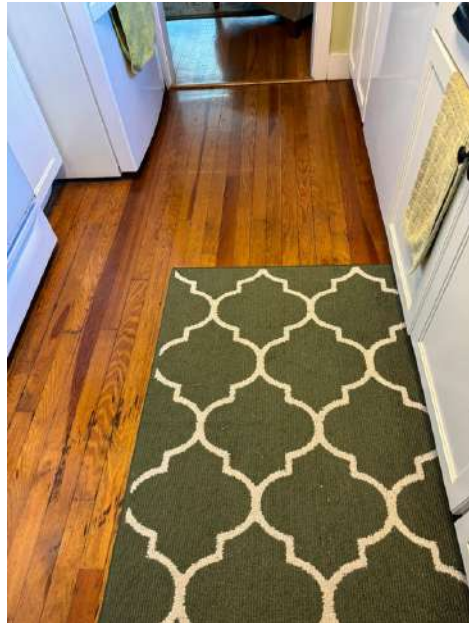
**Flooring Condition: Flooring**

Hardwood flooring throughout house with the exception of tiled floor bathroom

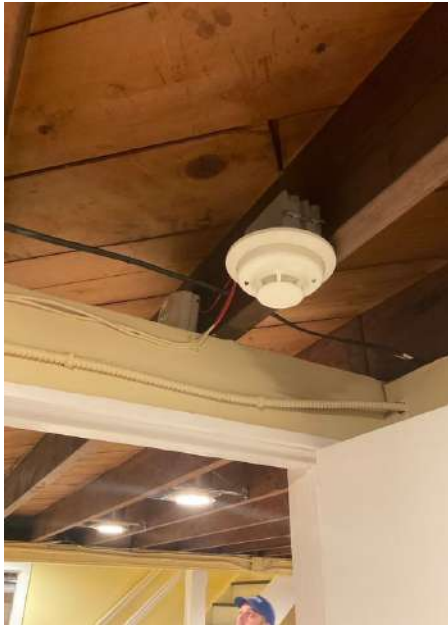
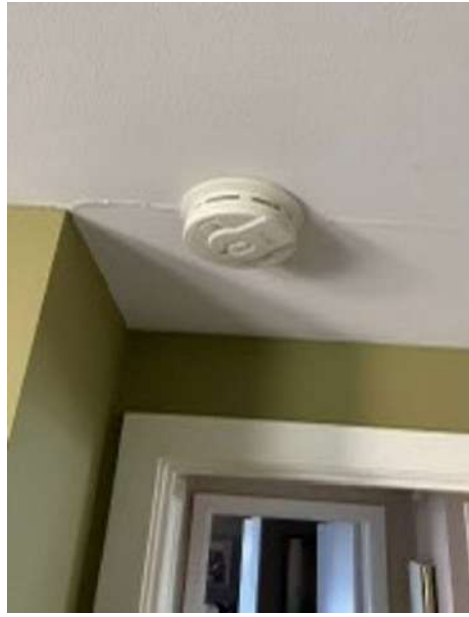
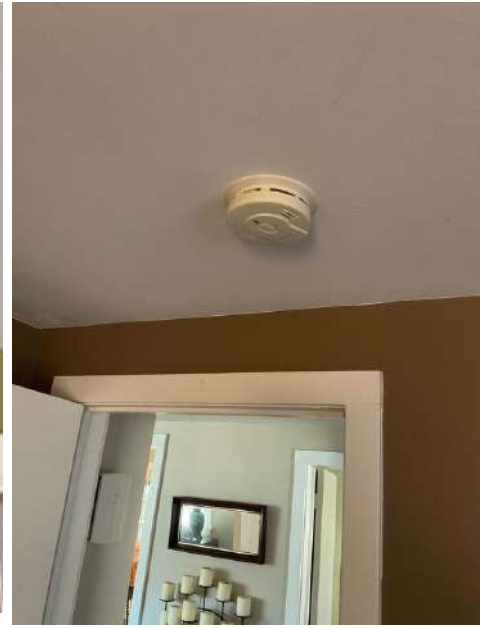
Bedrooms and basement

Smoke Detectors: Operated when tested

The two bedrooms to the right of the house, front and back and in the basement

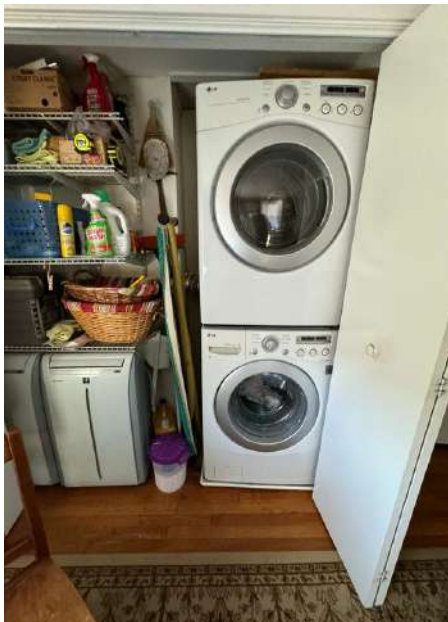
Bedroom main floor, right of hallway

Stackable, washer and dryer observed in closet. No access to water shut off in the closet area. Recommend contacting a licensed plumber to install washer shut off with easy access in closet to washer. Dryer vent was clear and clean at time of inspection.

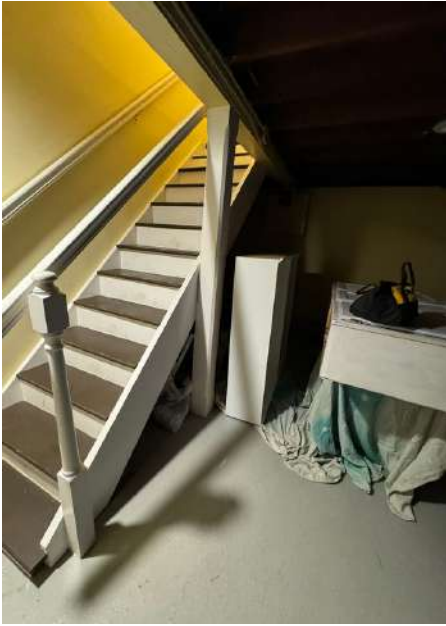
Kitchen area to basement

Stairs & Handrail: Basement stairwell

Left side of basement stairwell while descending has a wide open area. This could be dangerous for small children. Recommend contacting license home remodeling company, rectify issue.

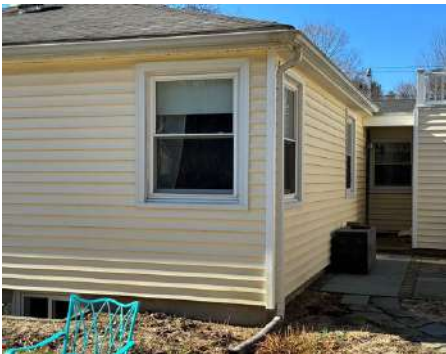
Main floor

Window Condition: Double hung vinyl windows

The windows main floor appeared to be recently replaced. They are all double hung vinyl energy efficient replacement windows. There appeared to be no sign of window, sealant, loss, or fogging between the pains. All of the windows that were tested function as they should at time of inspection.

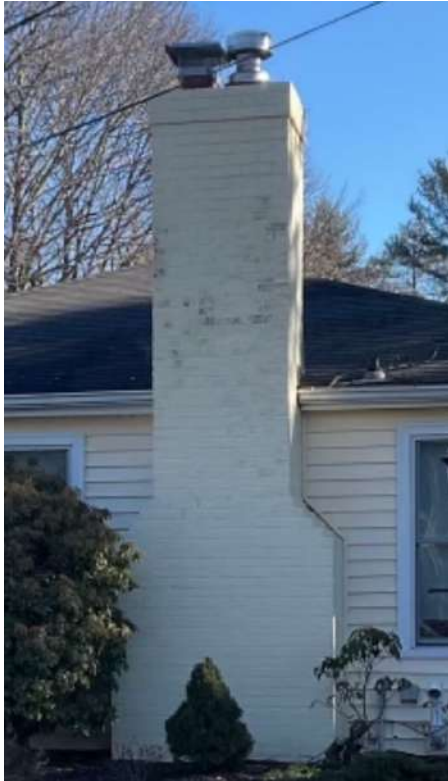
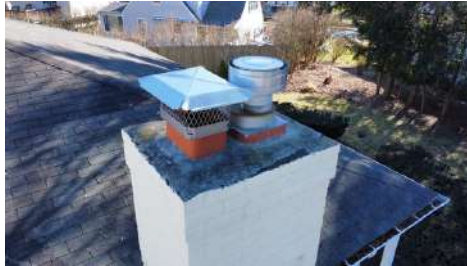
Front of house street side

The chimney is attached to the exterior of the house. It appears to have recent work done on it. The clay liner was in good shape. The cement cap or crown was fairly new and both flues had fairly new rain caps. Installed.

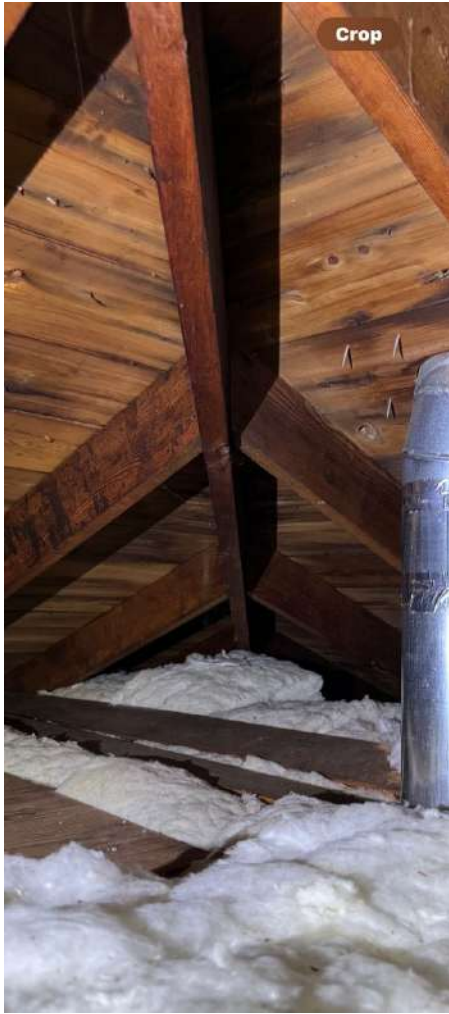
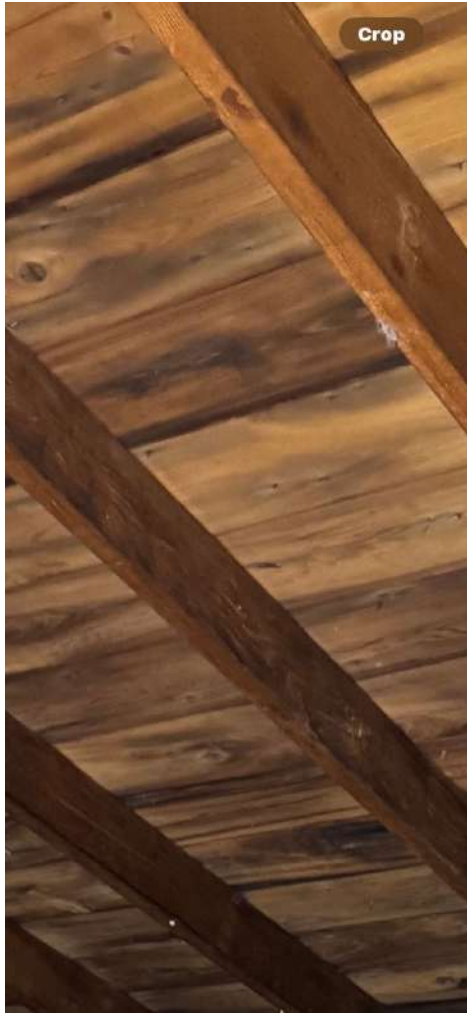
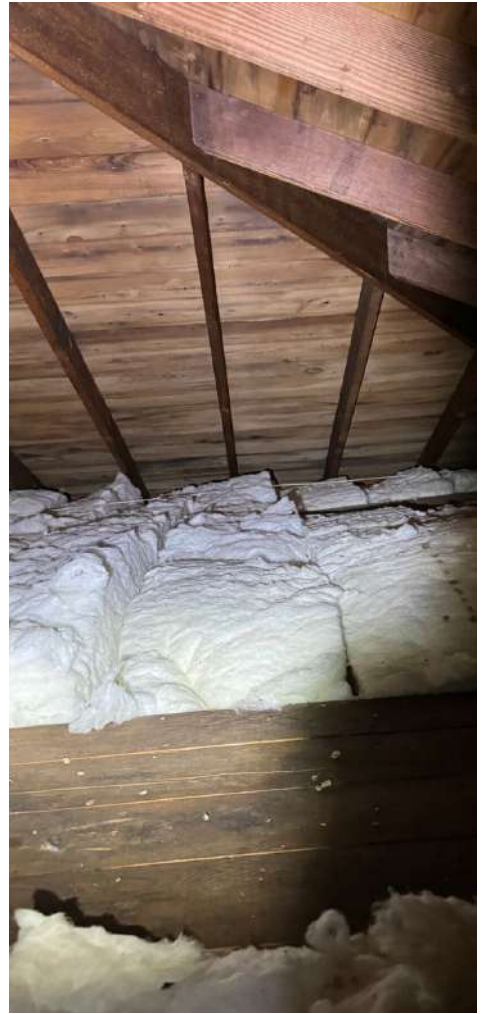
Interior attic

Add structure appeared sound with no deficiencies observed at time of inspection

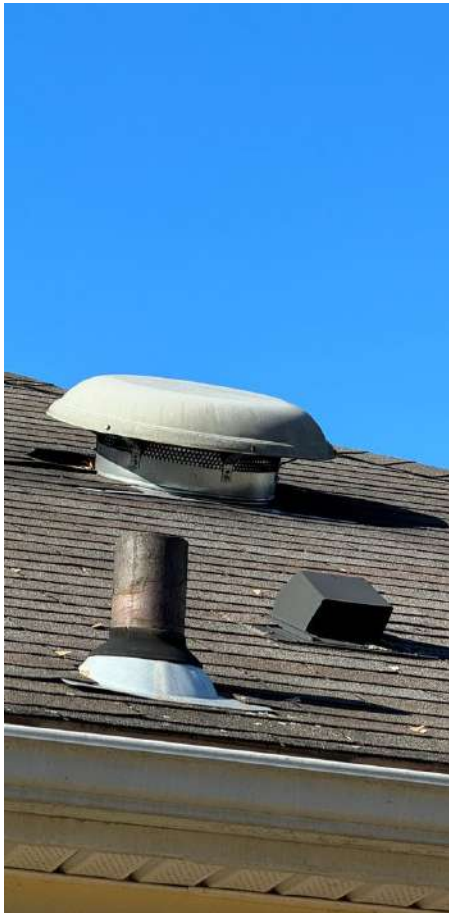
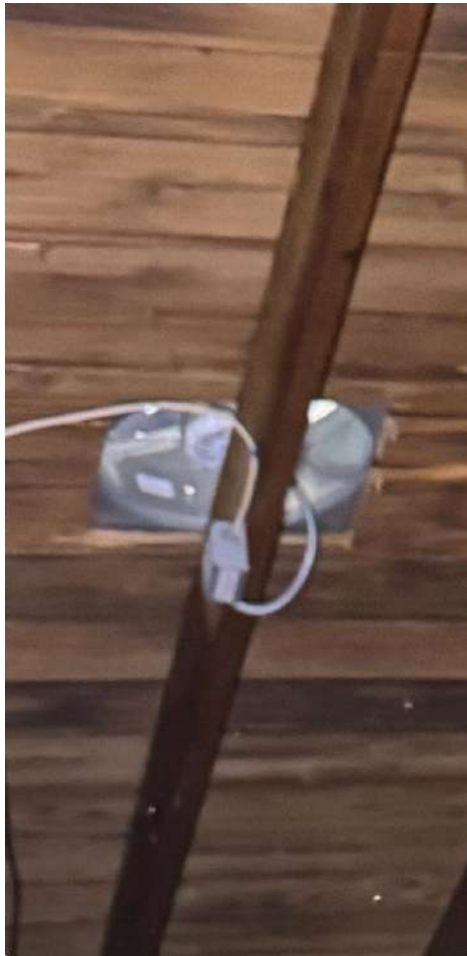
Attic back of house

Ventilation: Thermostatically controlled power vent
